## TECHNICAL ADVISORY BULLETIN

### Reduce Strain on LPR48-300 Input Cable

Date: 23-Jun-2020  
Model #: LPR48-300  
Part #: PN 0120049-001

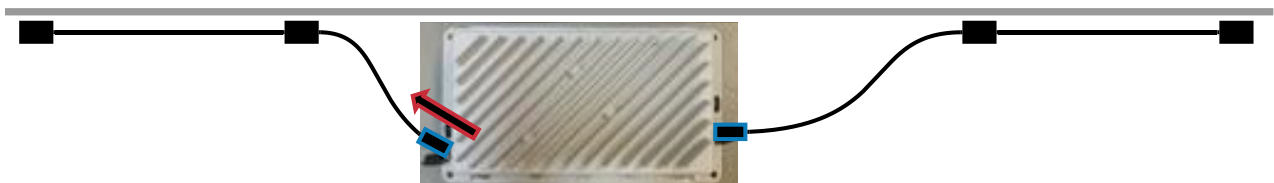
Insufficient cable length between the strand connection and the LPR48 module input can lead to excess strain on the cable housing. This creates an upward pulling force on the housing which increases the chance of the **internal connector seal being deformed**, which may lead to water ingress in some scenarios. An example of this is shown in *figure 1*.

*Figure 1 - Excess strain on the input of the LPR48 module can pull the cable housing upwards and possibly deform the internal connector seal*

- Provide instructions with diagrams for **two different solutions** on how to route the cable to **avoid unnecessary strain**, which are to be used during installation.

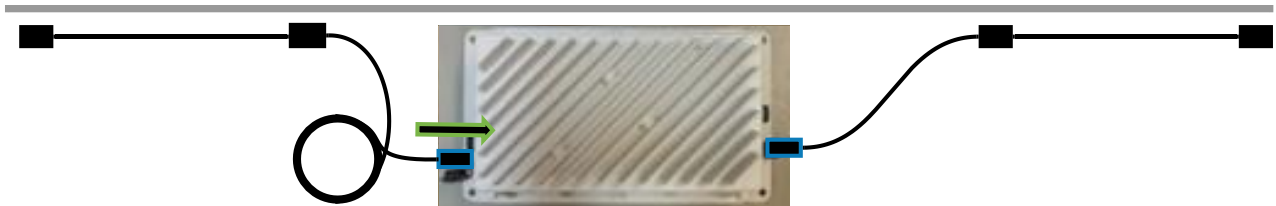
*Figure 3 - Strain relief loop allows the cable connector to enter horizontally which eliminates the upward pulling force on the cable housing*

The second solution is to create a **4" strain relief loop** underneath the strand before connecting to the input of the LPR48 module. This ensures that the cable connector enters the module horizontally to avoid excess strain on the housing.

*Note: Verify that the loop of the cable does not sit below the bottom of the LPR48 Module.*
